FLUX REGENERATION SYSTEM

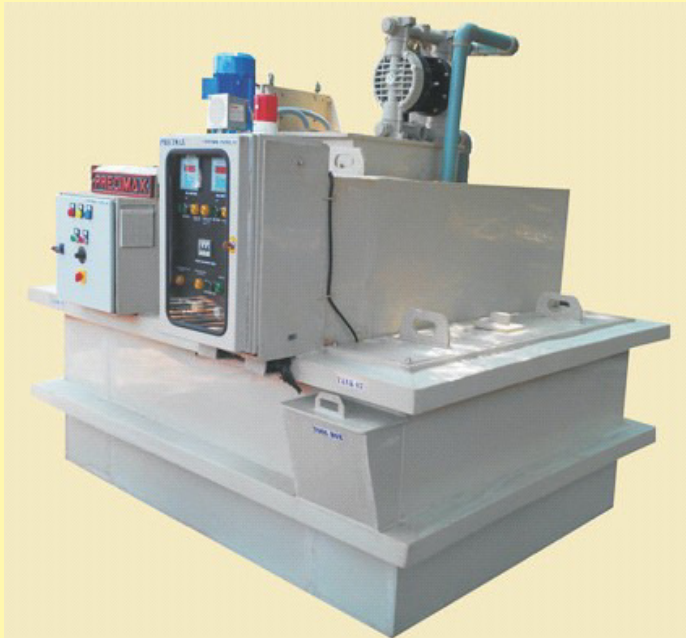
The fluxing bath is being polluted by acid residues and above all by dissolved iron. Consequently it makes the quality of the galvanizing process worse; moreover iron being entered by a polluted fluxing flow into the galvanizing bath binds itself with zinc and precipitates to the bottom, thus increasing dross.

A continuous treatment of the fluxing bath will help you get rid of this problem and reduce the zinc consumption dramatically.

The continuous depuration is based upon two combined reactions, an acid-base reaction and an oxide reduction which correct fluxing acidity and simultaneously cause the iron to precipitate.

The mud collected at the bottom is regularly being tapped and filtered.

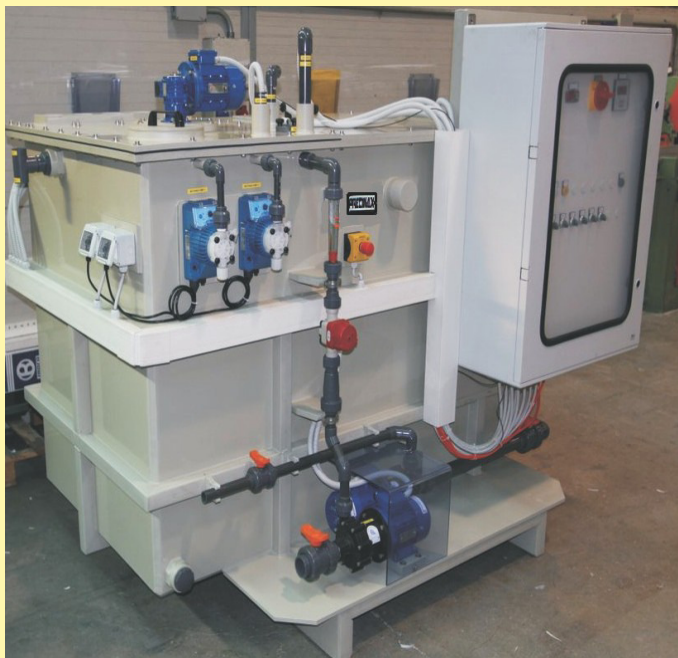
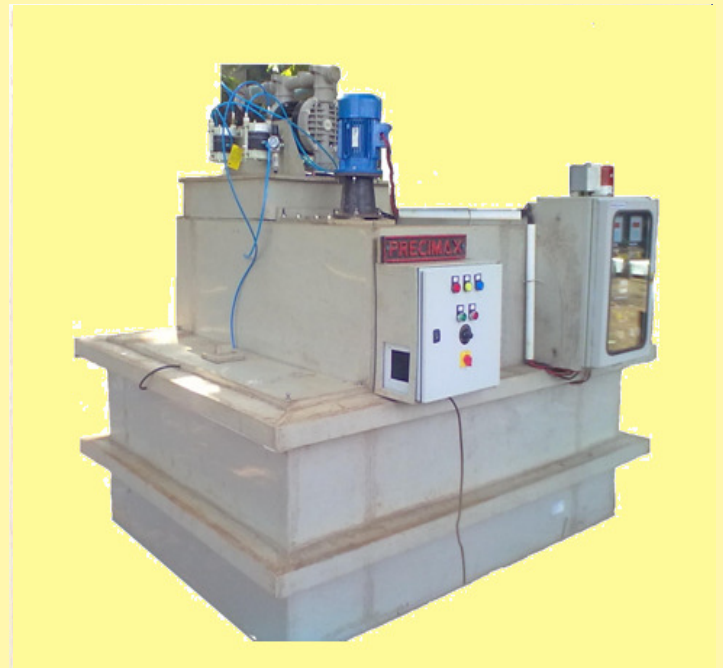
View of a continuous flux regeneration system
